Manhole Inspection Summary

Manhole # S29KK_049MH

Insp Date: **7/16/07 11:36 AM**

Location Address: **1934 MOUNT ROYAL TERR**

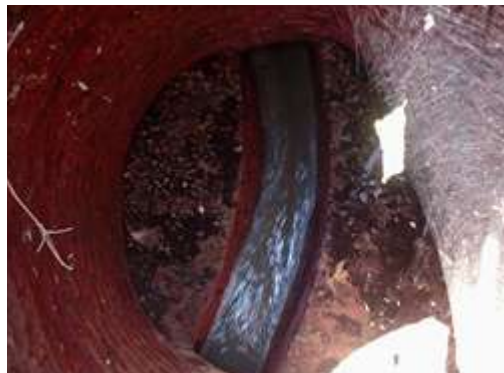
Top View

Corroded steps. Evidence of surcharge - Bench debris.

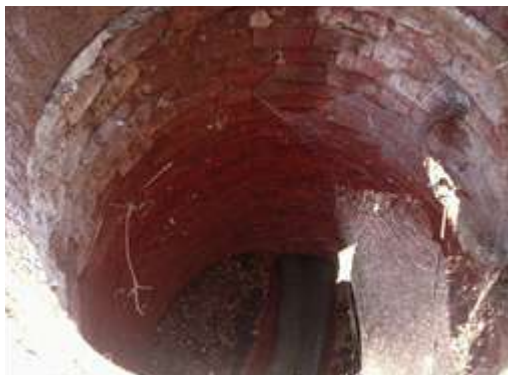
Defect

Frame leaks. Adjustment deterioration and infiltration. Barrel infiltration.

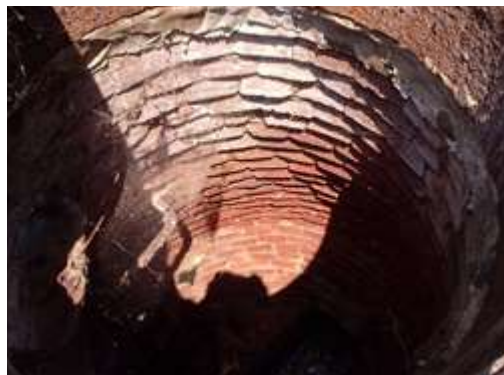
Defect

Frame leaks. Adjustment deterioration and infiltration. Barrel infiltration - other side.

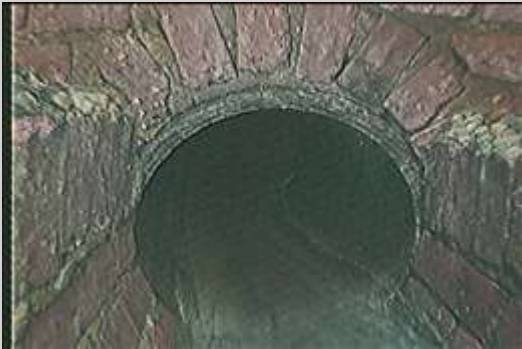
12 in. Circular Gravity Sewer Pipe Out @ 12 O'Clock

Channel deterioration.

Infiltration: **Evidence** Pipe Seal Cond: **Unknown**
